22 May 1964

Good *84*
(9) TECHNICAL REPORT

(6) FLEXTENSIONAL TRANSDUCER AND REFLECTOR

NORTH AMERICAN AVIATION, INC., COLUMBUS DIVISION

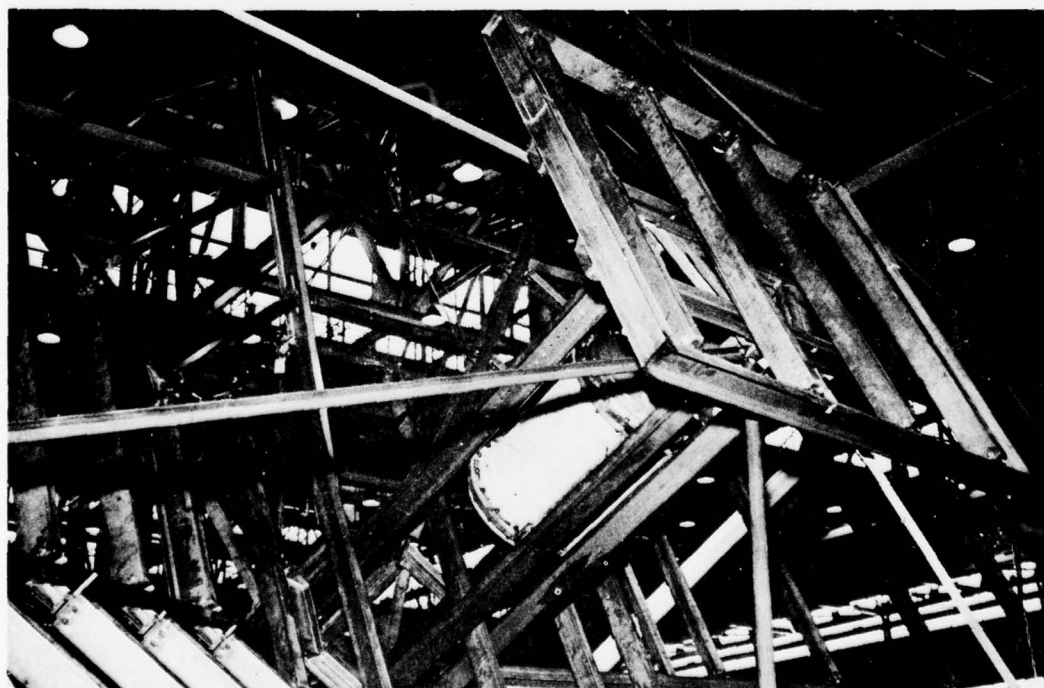
Figure 3. Close-up View of Transducer in the Parabolic Reflector

The combination of piezoelectric transducer and compliant-tube reflector, Figures 2, 3, and 4, was tested at NEL's Lake Pend Oreille Calibration Station in Idaho during March. The measured behavior of the transducer-reflector combination is depicted in Figures 5-8 while Figures 9 and 10 apply for the transducer alone. The polar patterns in Figure 5 are not unlike those from a 24-foot circular piston which, ideally, has a directivity index of 15.6 db at 400 cps. The directivity index of the compliant-tube reflector is closer to 14.5-15.0 db and the difference is due, in part, to the 90-95% reflection efficiency of the compliant-tube array and, in part, due to the shaded insonification that results from the close-in position of the focus.
